## Robinson Helicopter Company Accident Report

AIRCRAFT MODEL:	<u>R44 Clipper I</u>
SERIAL NUMBER:	<u>1295</u>
REGISTRATION:	<u>N7530R</u>
ACCIDENT DATE:	<u>30 January 2018</u>
ACCIDENT LOCATION:	<u>Newport Beach, California</u>
NTSB IDENTIFICATION:	<u>WPR18FA077</u>

REPORT WRITTEN BY: Ken Martin

DATE: 17 June 2019

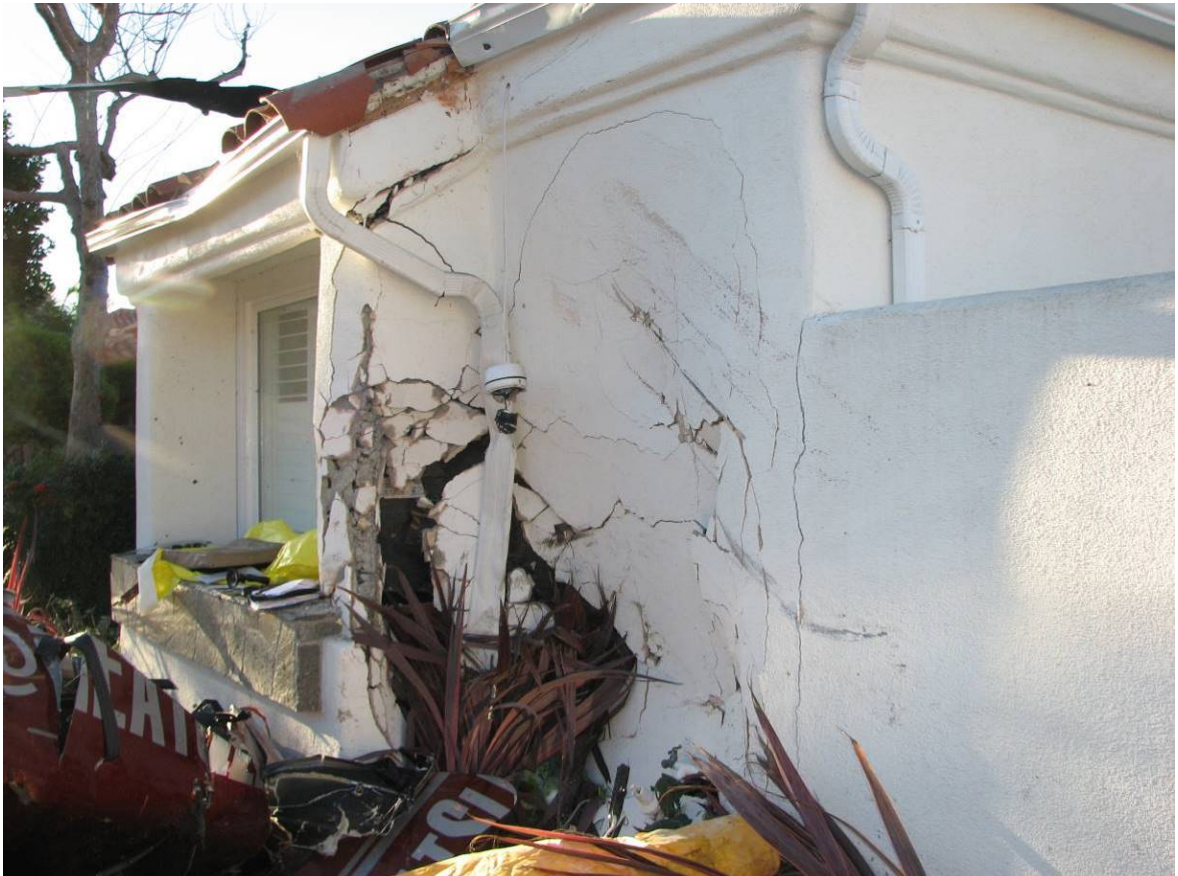
Damage to the house at 41 Egret Court

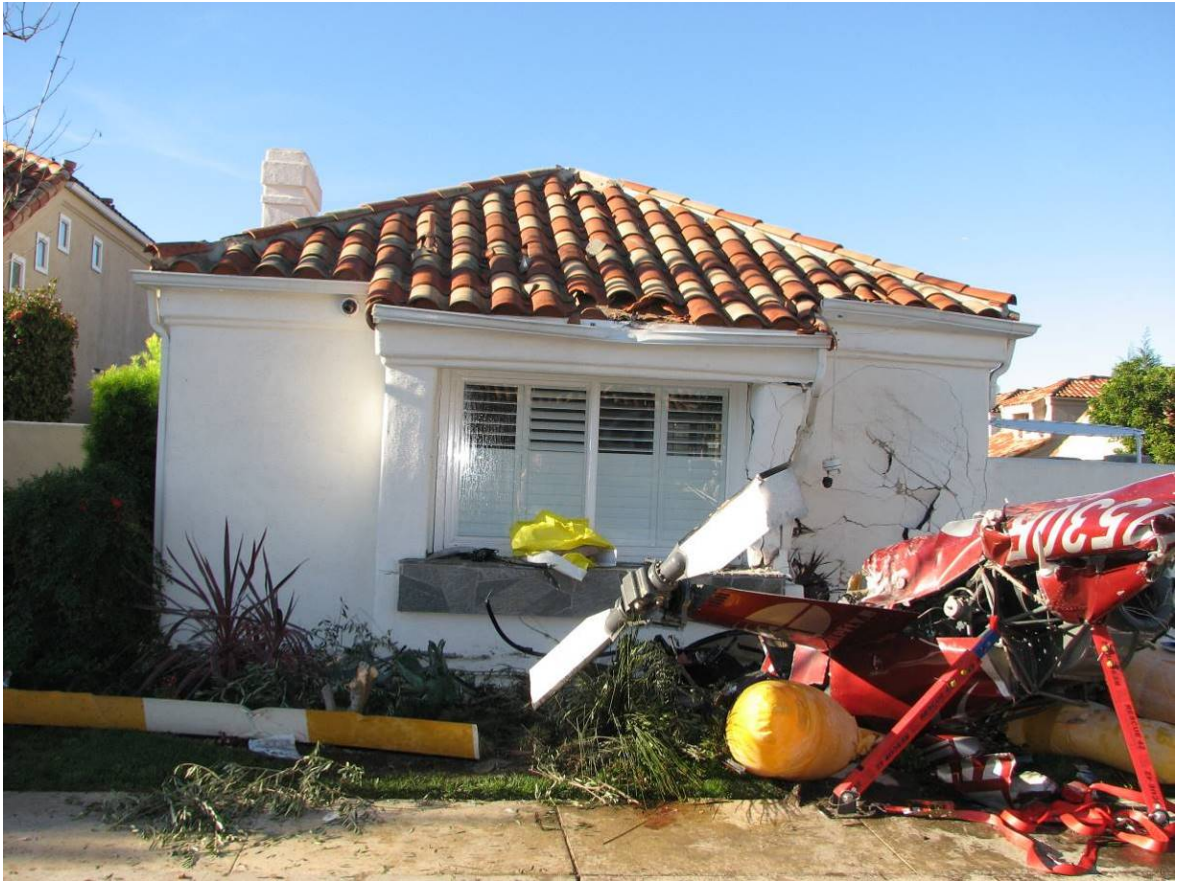
Damage to the house at 41 Egret Court

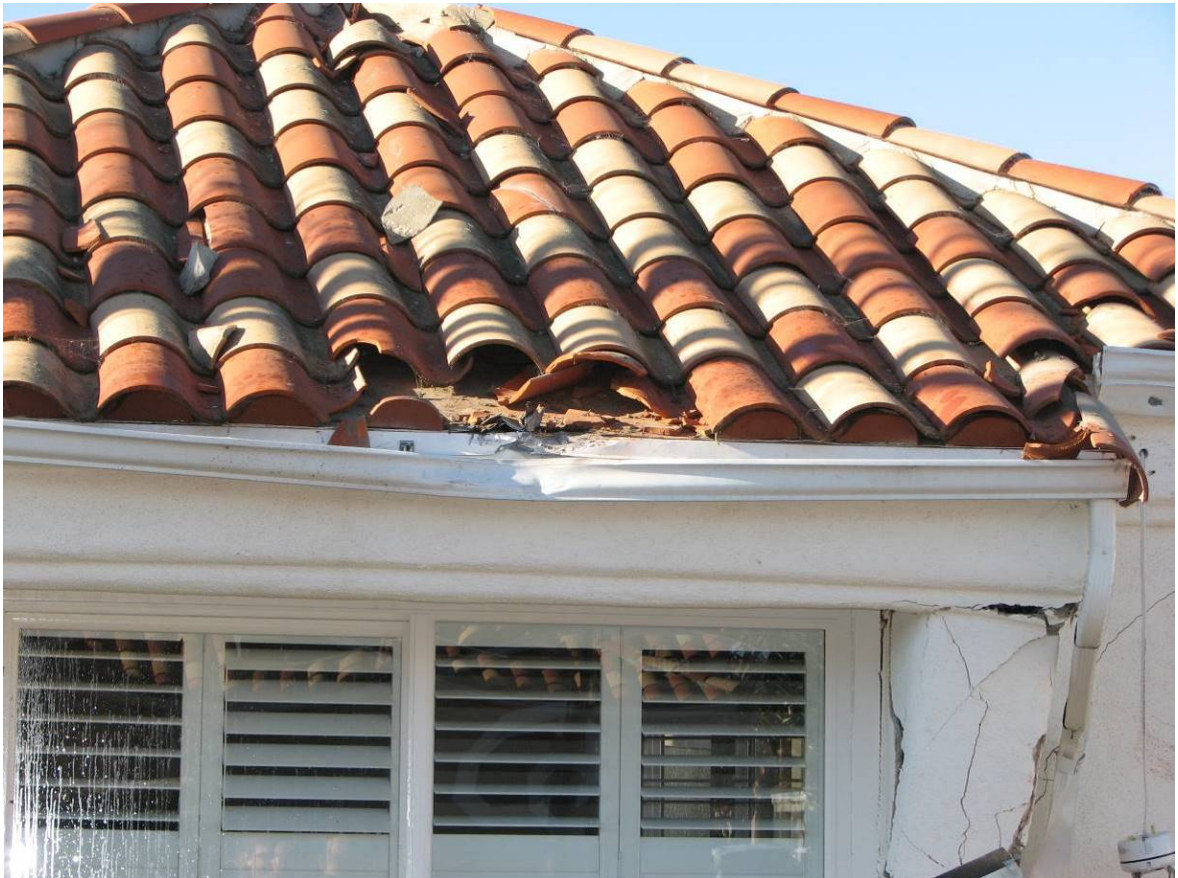
Damage to the house at 41 Egret Court

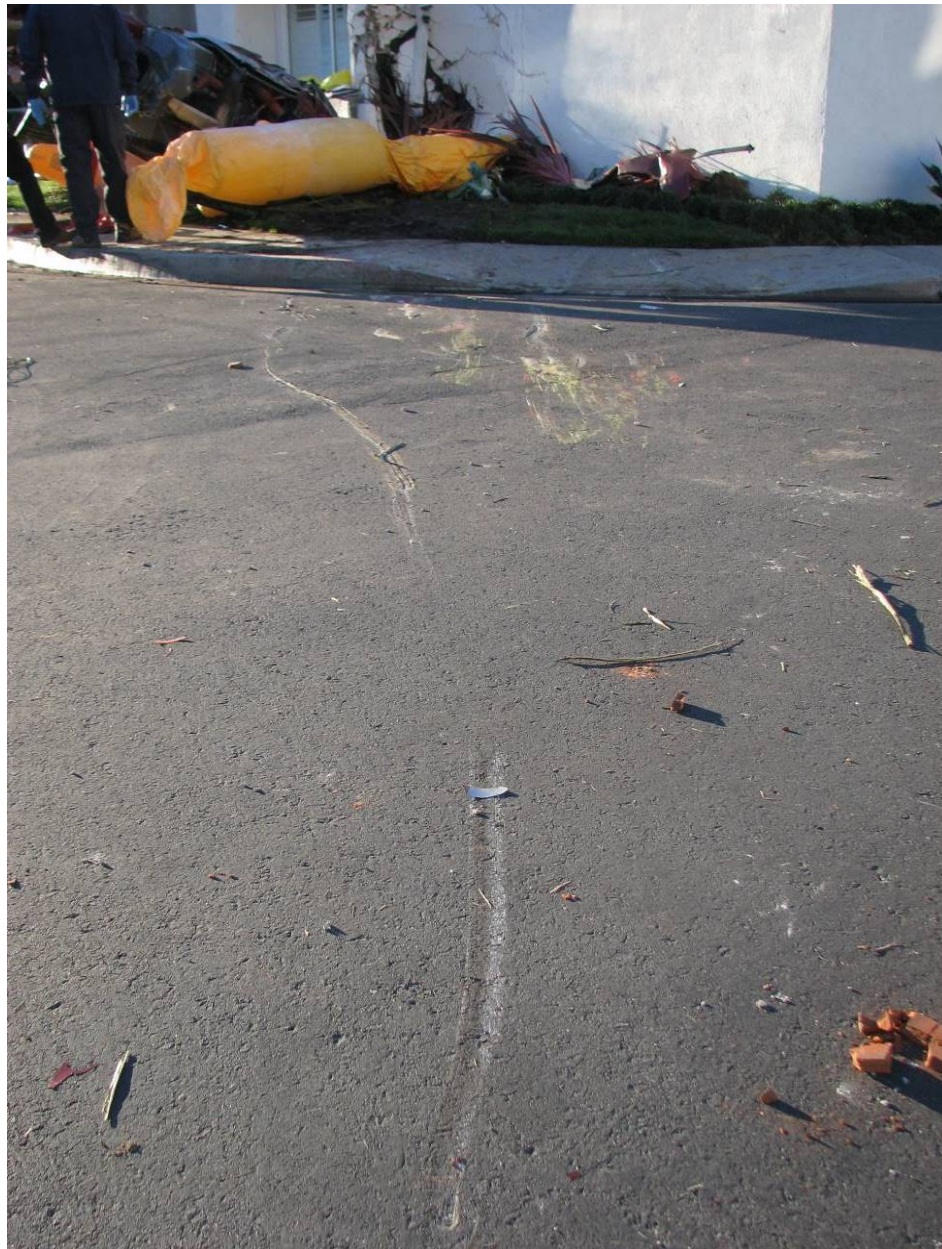
Ground scars and paint transfer in the street near 41 Egret Court

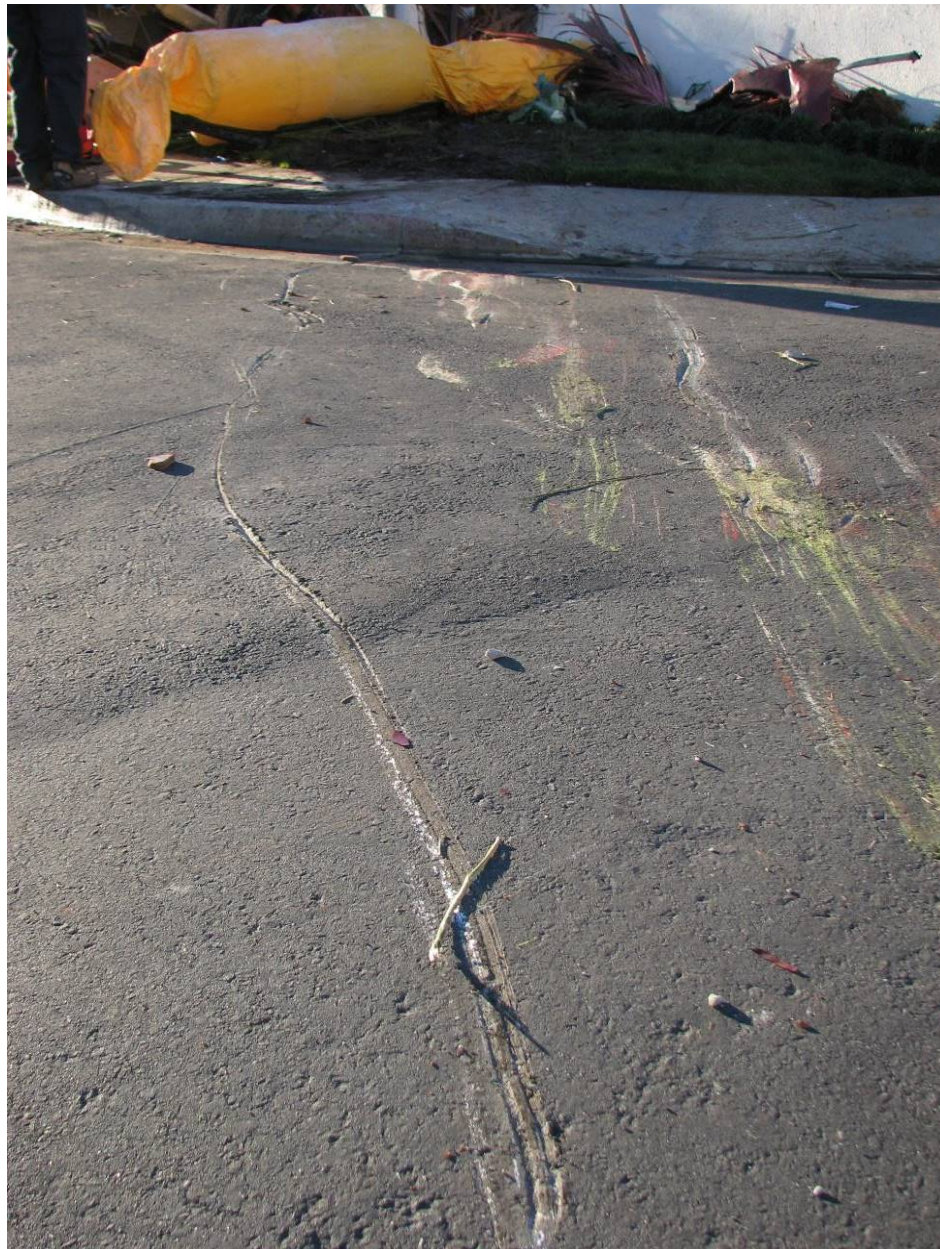
Ground scars and paint transfer in the street near 41 Egret Court

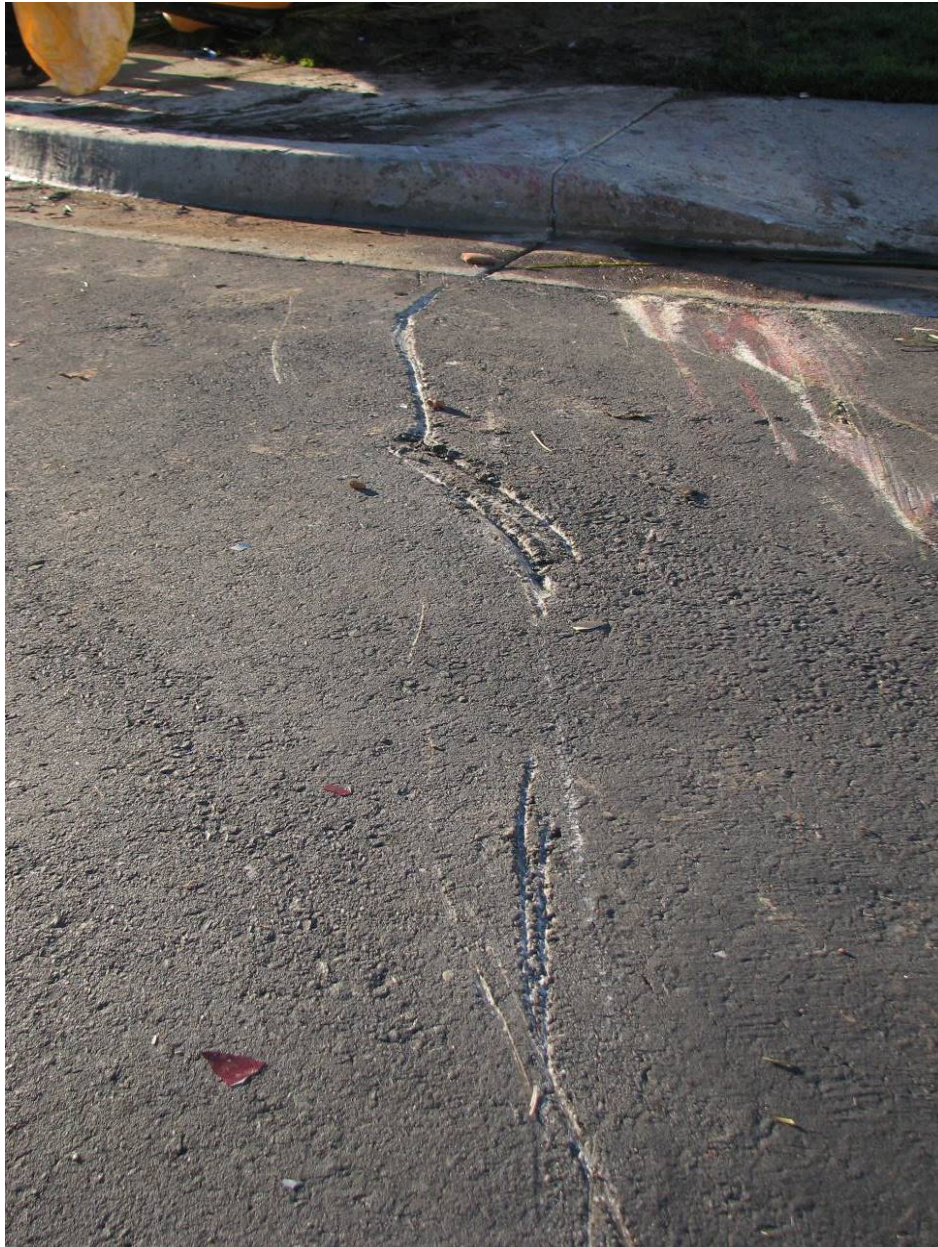
Ground scars and paint transfer in the street near 41 Egret Court

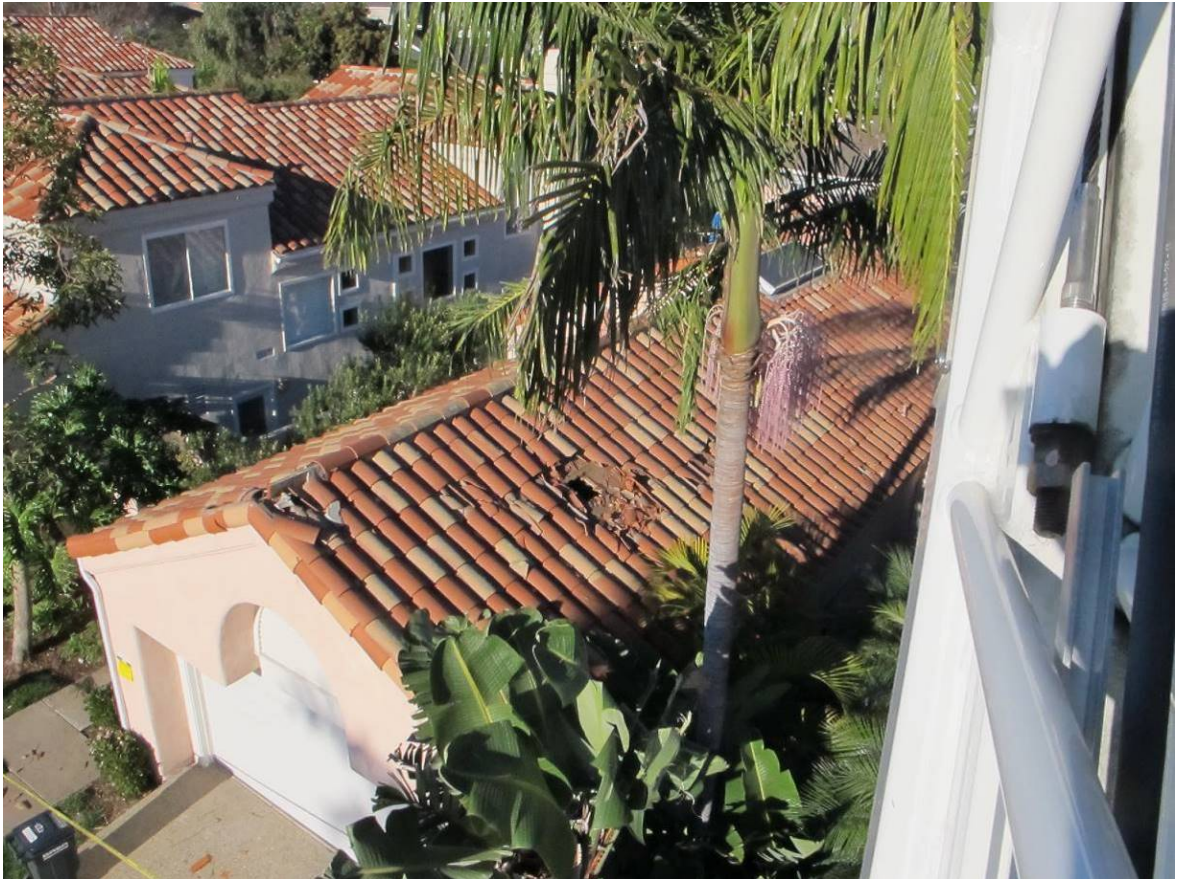
Damage to the house at 45 Shearwater Place

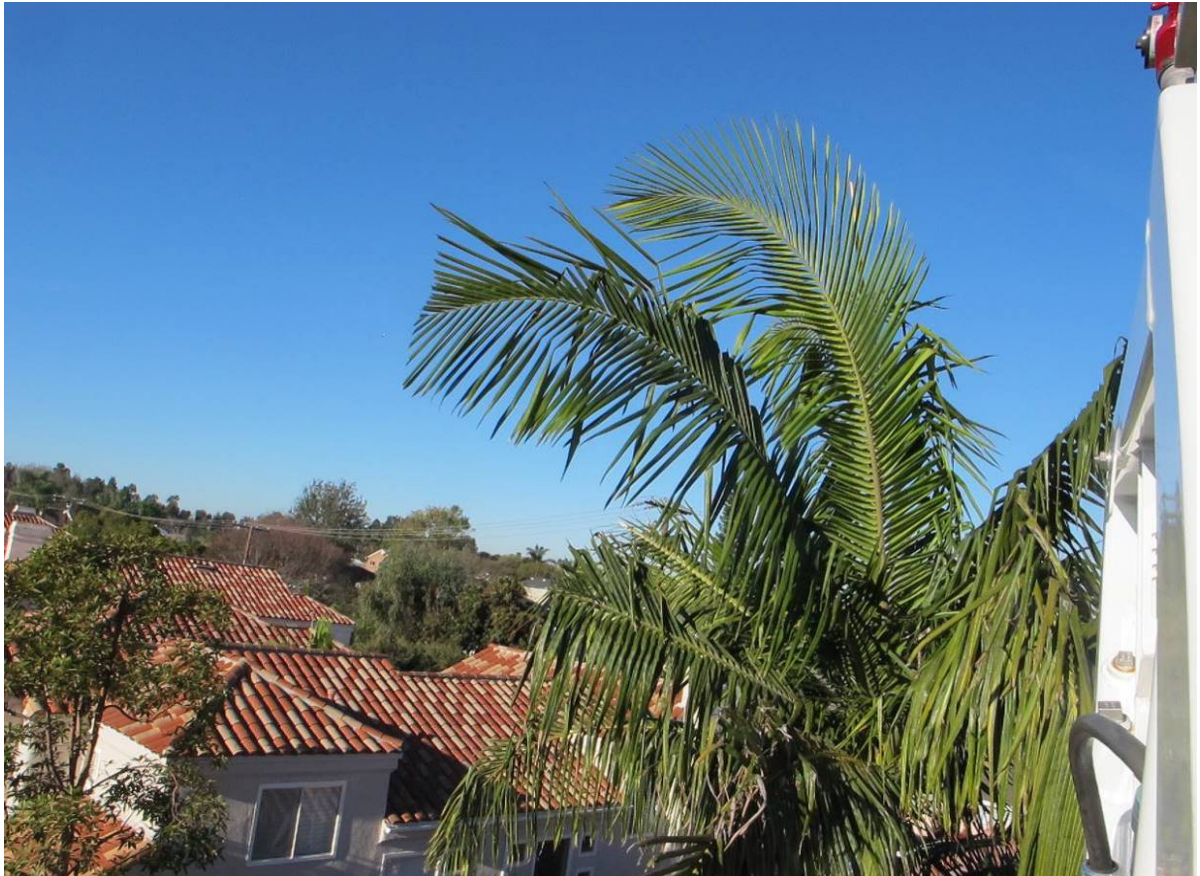
Damage to the tree at 45 Shearwater Place

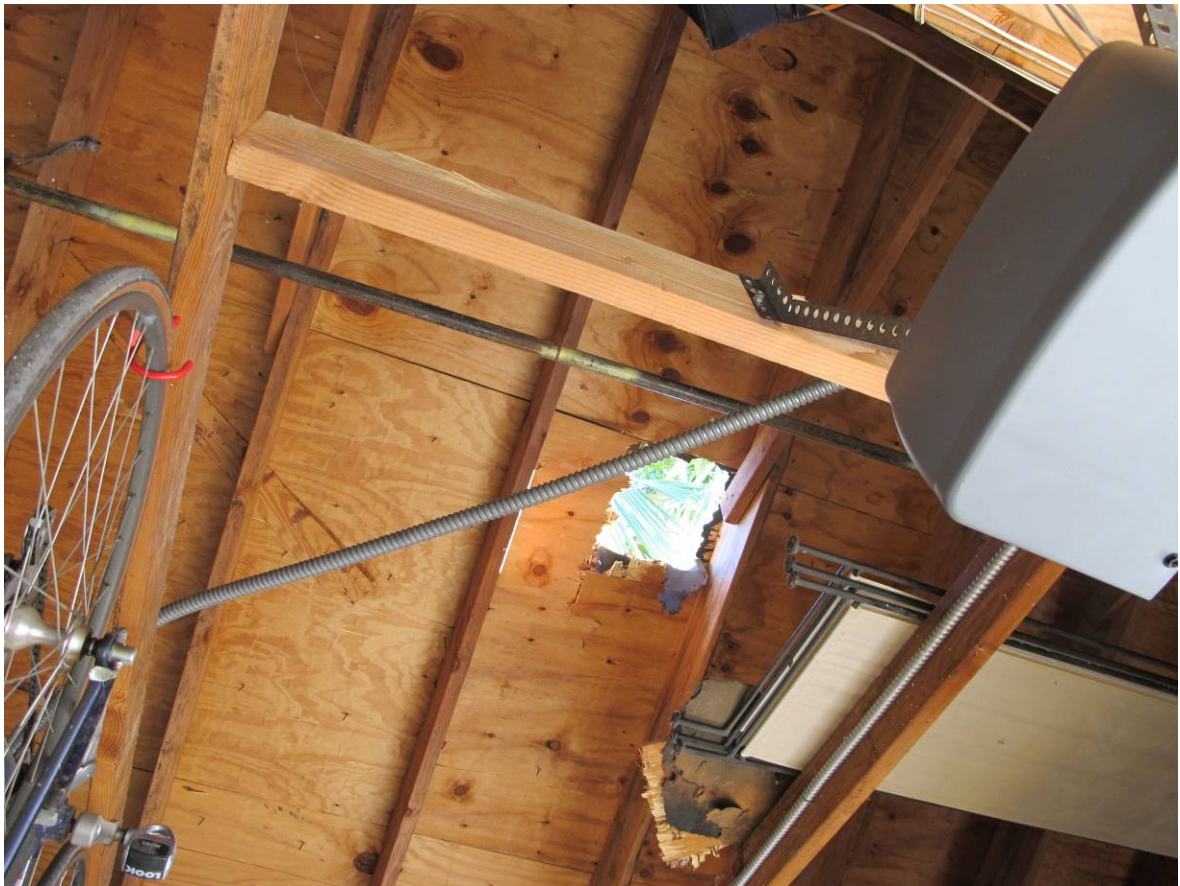
Damage to the house at 45 Shearwater Place

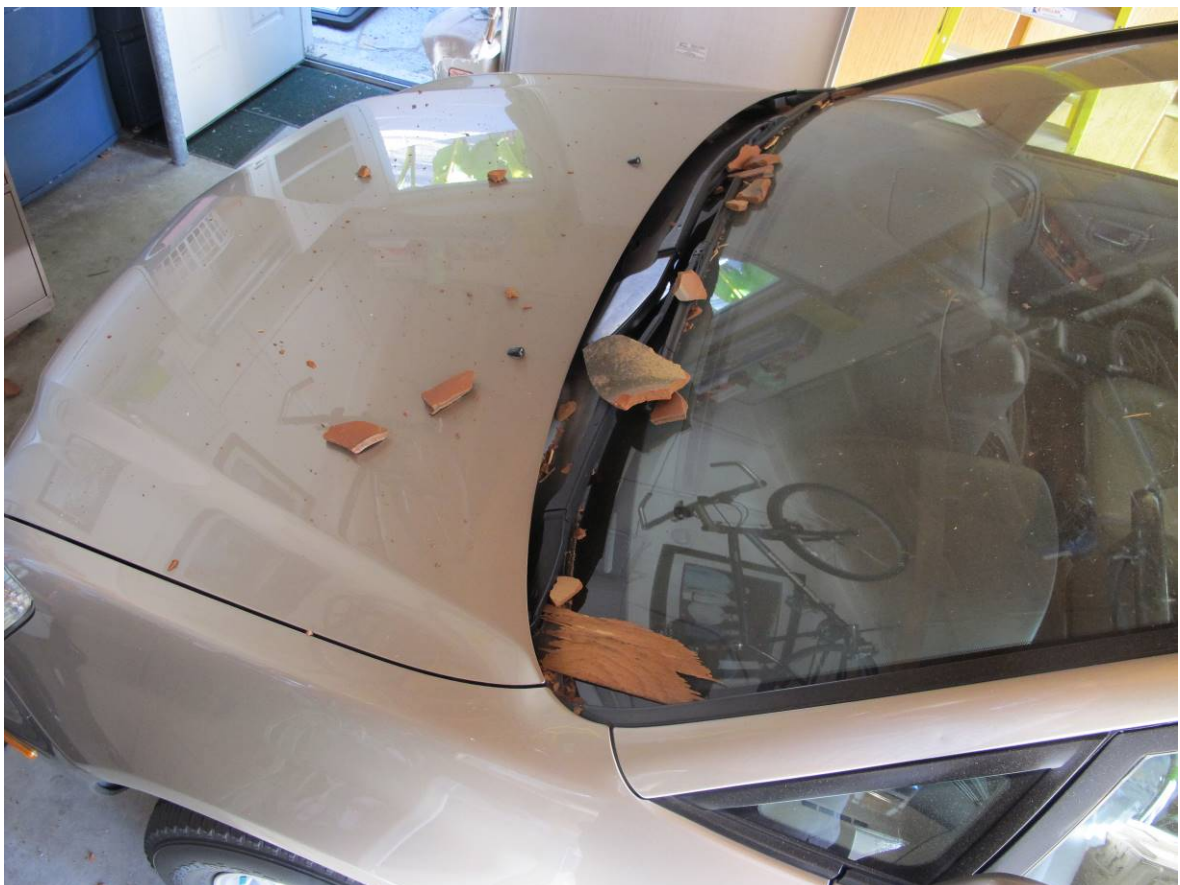
Debris from damage to the house at 45 Shearwater Place

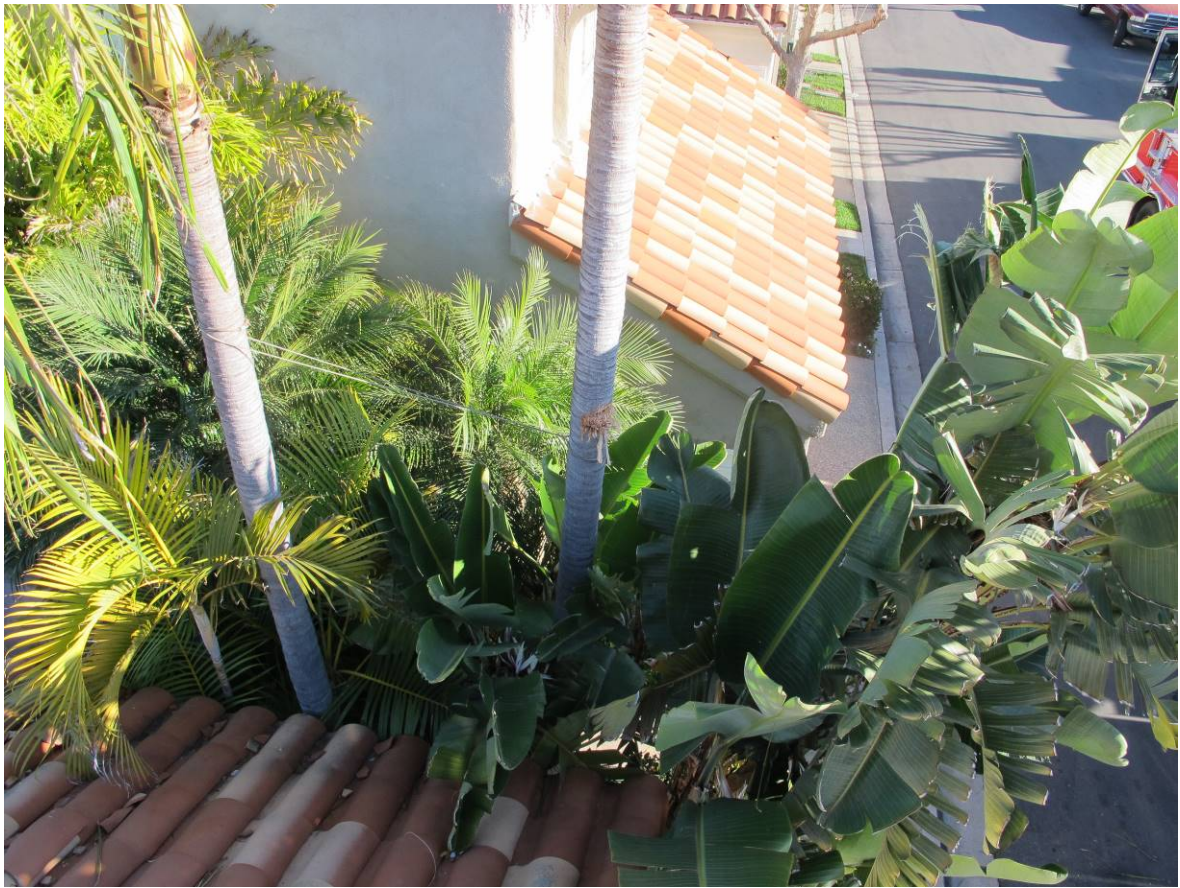
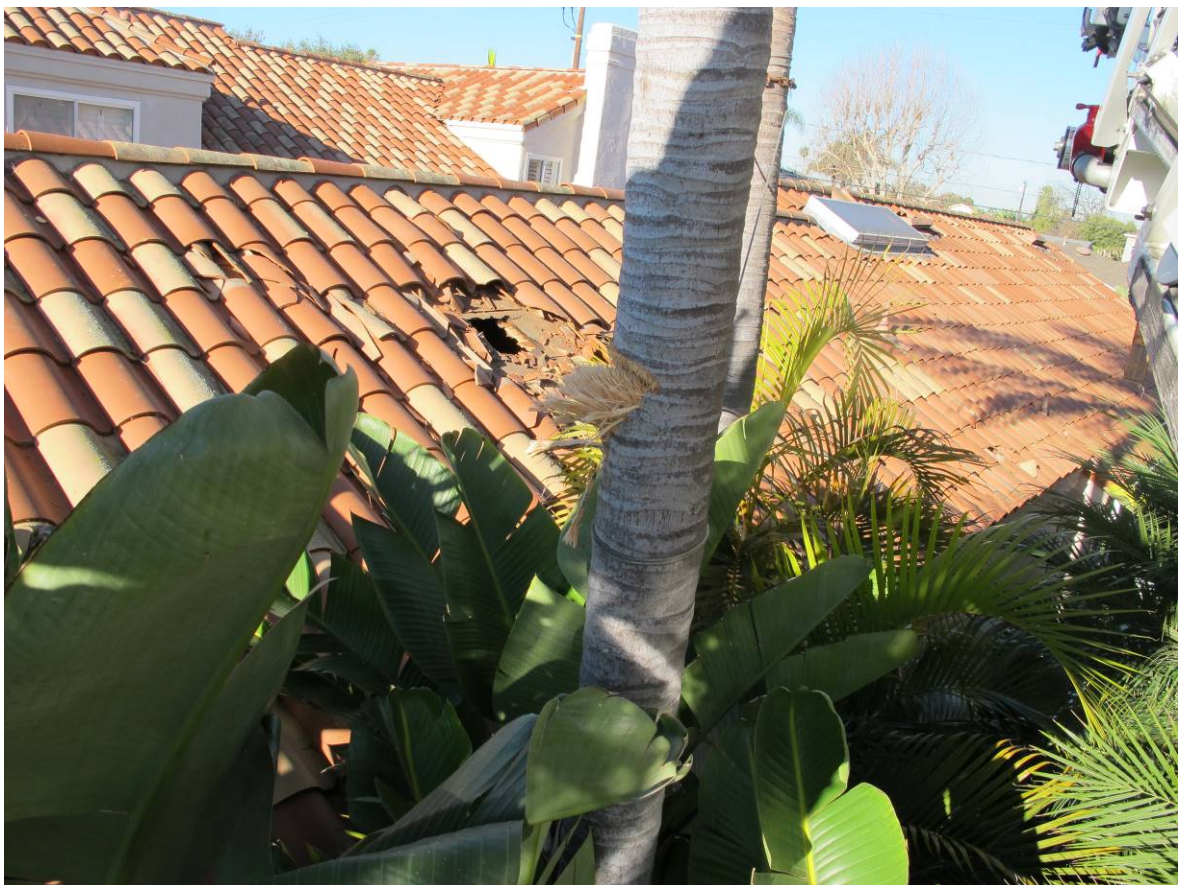
Above and below: Damage to tree outside 45 Shearwater Place

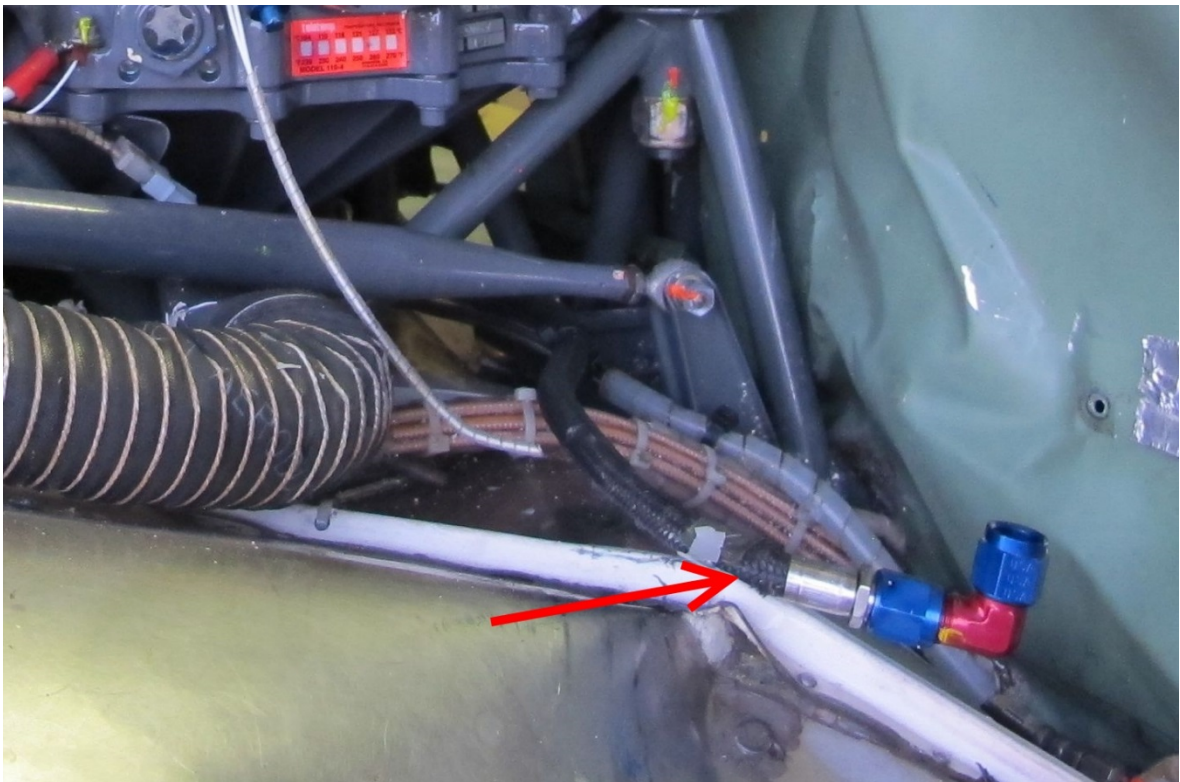
The cross feed hose was damaged near the auxiliary fuel tank outlet fitting. All other fuel lines and fittings remained secure and clear of obstructions.

Damage to crossover hose

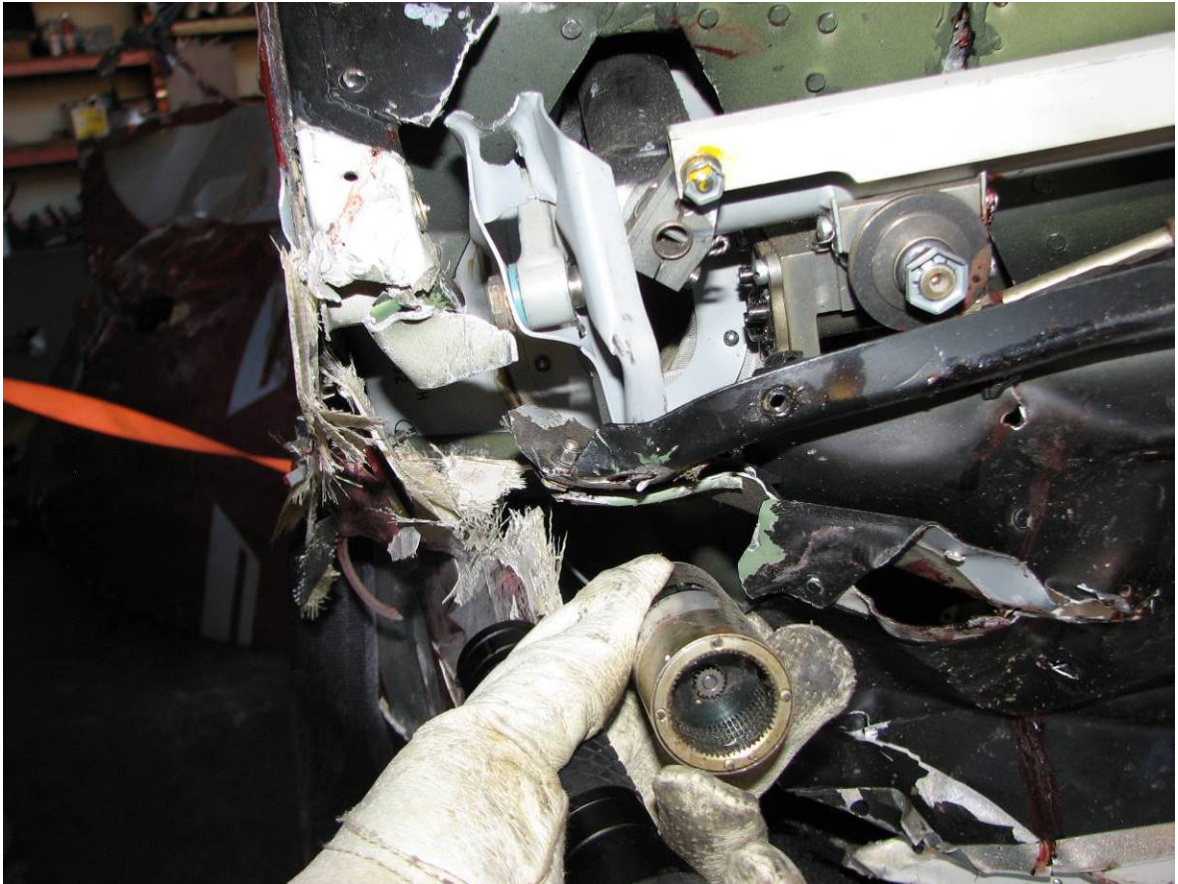
The governor control motor was disconnected from the housing. The surfaces of all of the fractured screws were angular and jagged.

The fractured governor motor assembly

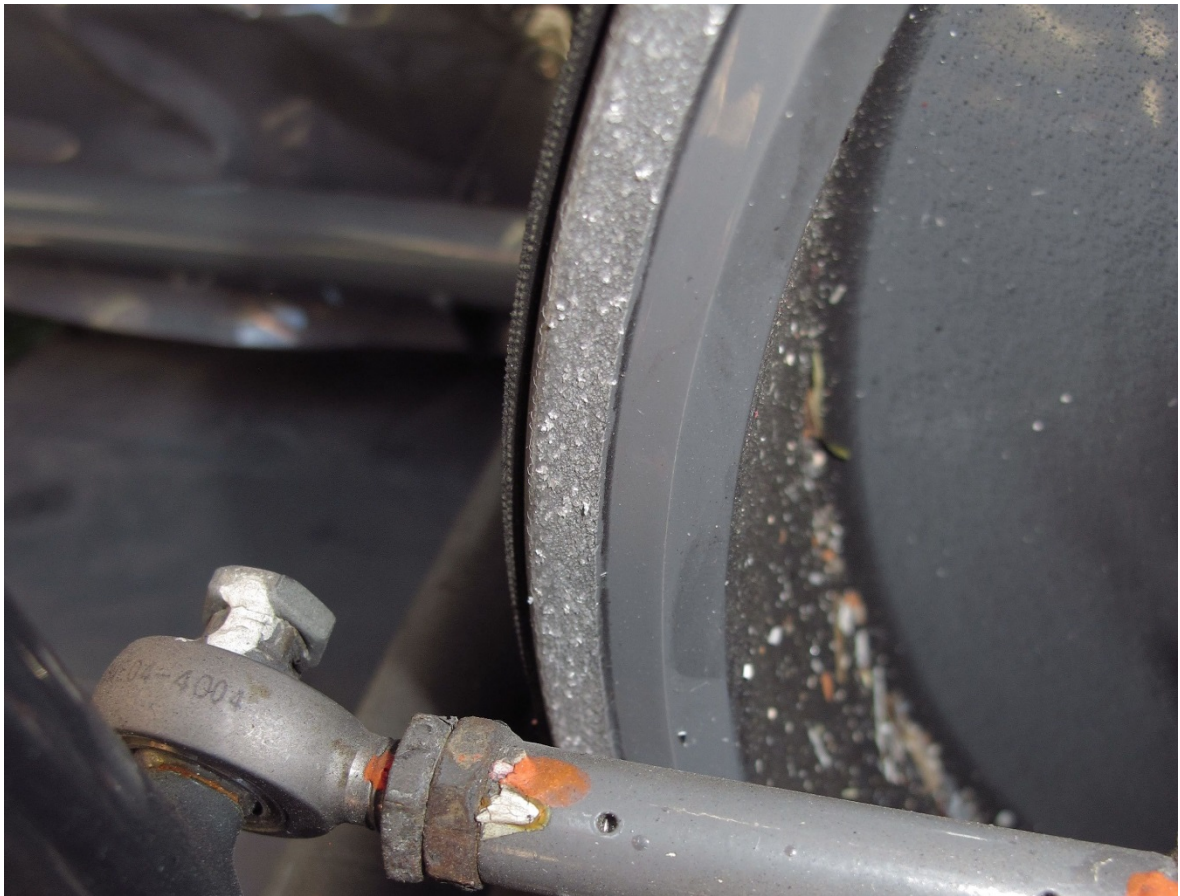
Scoring on the upper sheave, aft surface

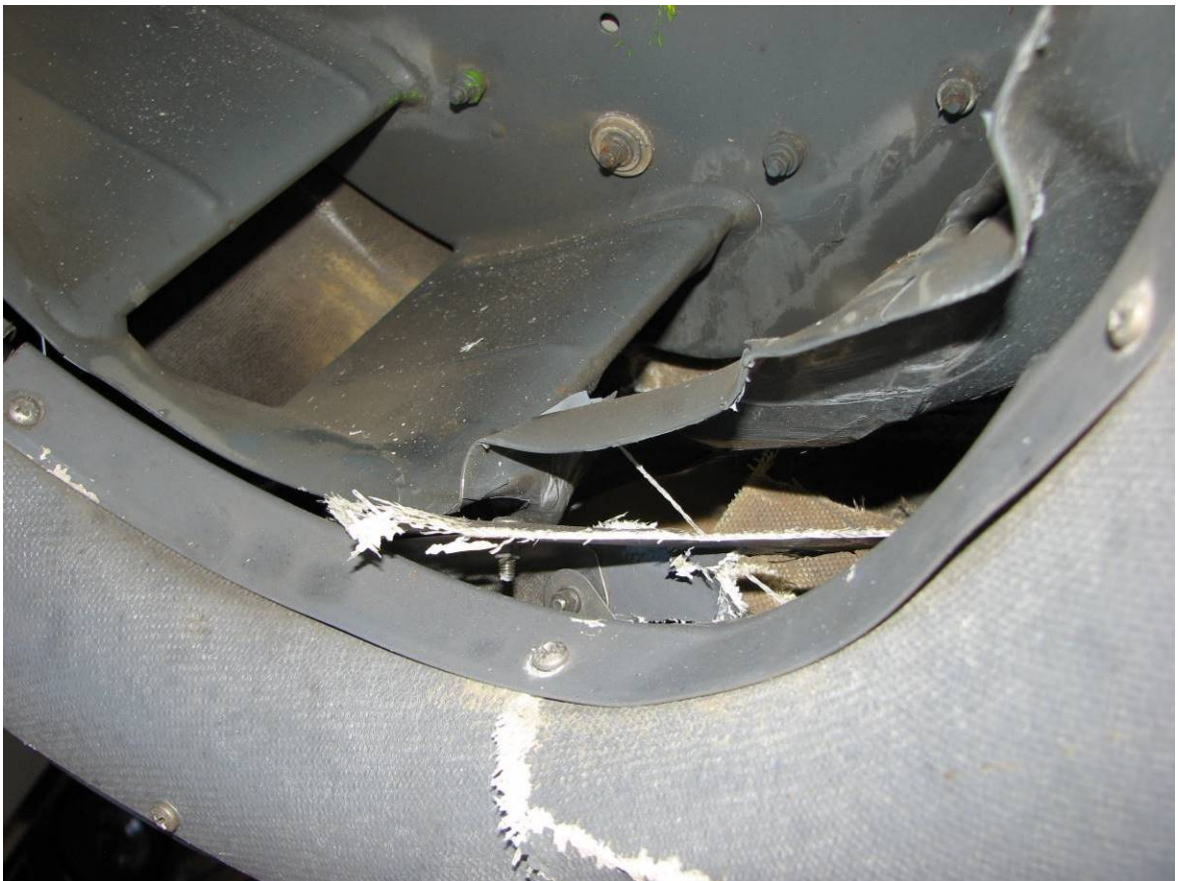
The powerplant sustained very minor impact damage. The exhaust system was crushed and deformed. A valve cover and surrounding cooling panels were dented. The cooling fan was crushed on the lower section, between the four and eight o'clock positions. The cooling scroll was crushed in the same area. The airbox was crushed and separated from the carburetor. The air filter appeared to be clean. The ignition wires were crushed and some were cut/separated.

Impact damage to engine cooling fan

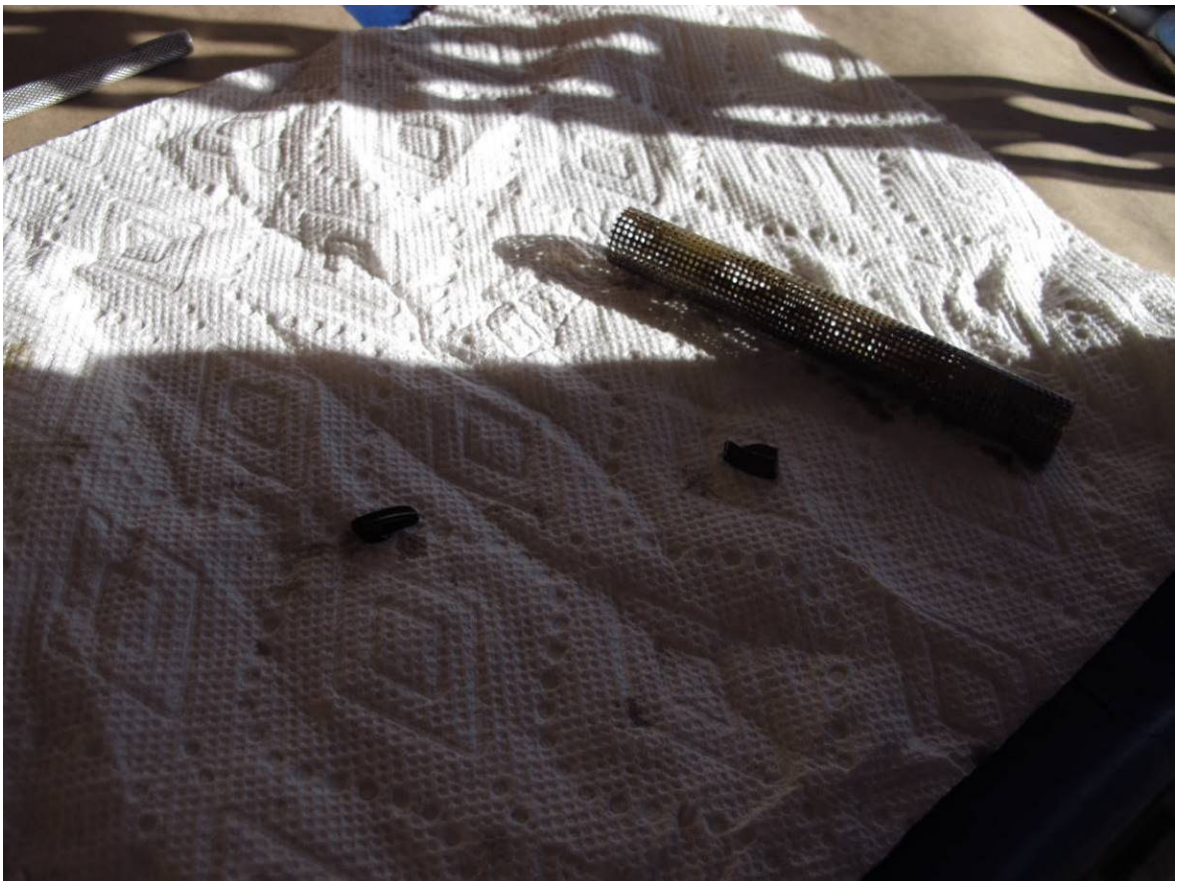
The crankshaft was rotated by hand more than 360° with no anomalies. Suction and compression were present in all cylinders. The oil sump screen was removed and photographed. Small pieces of magneto drive cushion were found in the screen.

Pieces of magneto drive cushion found in oil sump

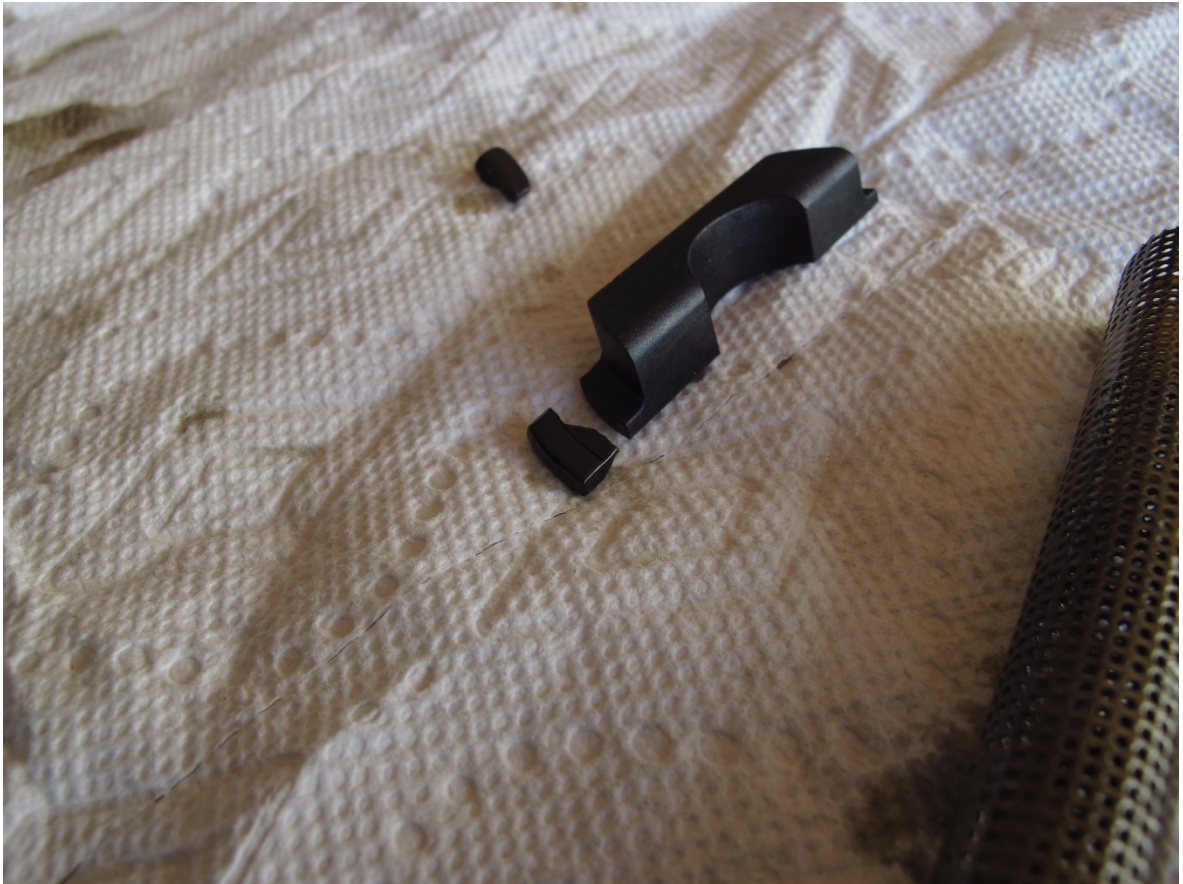
The magnetos were removed, revealing a magneto drive cushion missing two small pieces. The magnetos were reinstalled and set to proper timing.

Magneto drive cushion with separated pieces.

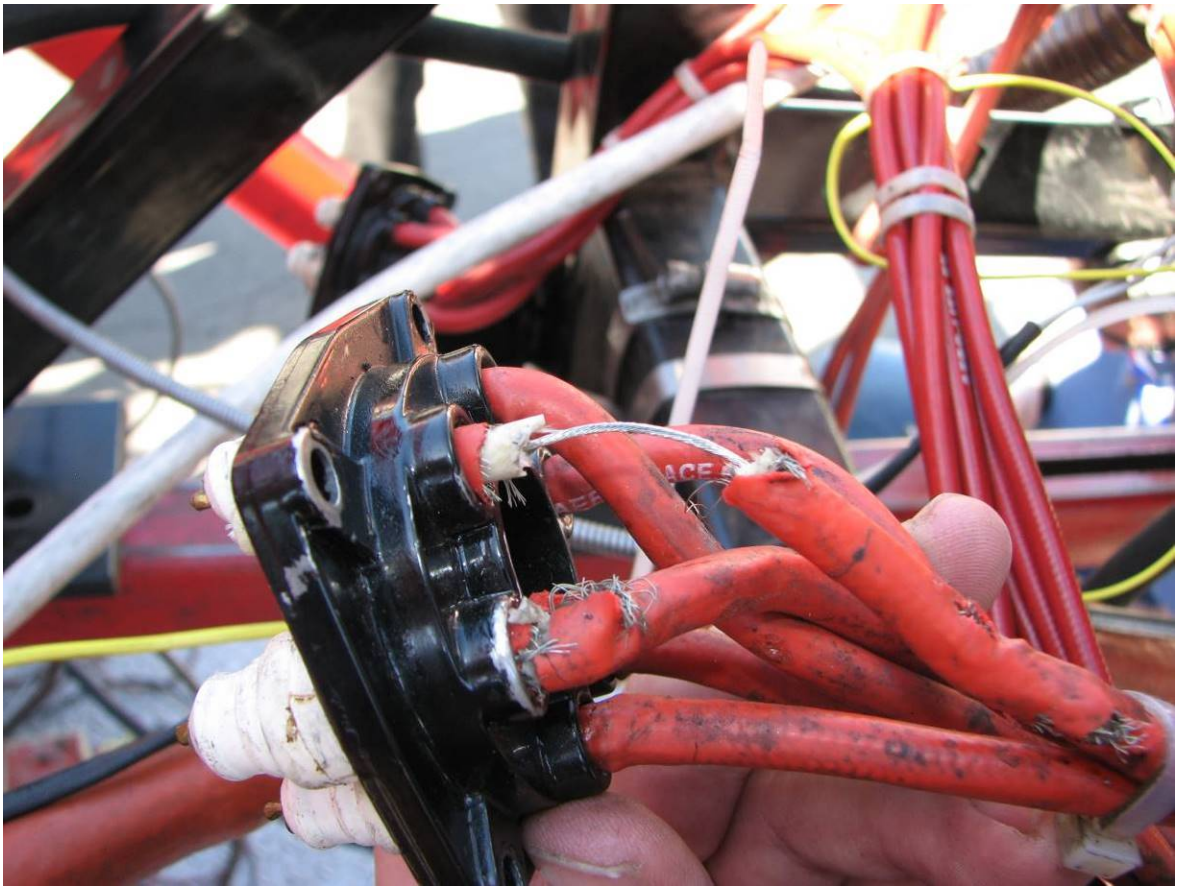
Damaged magneto harness

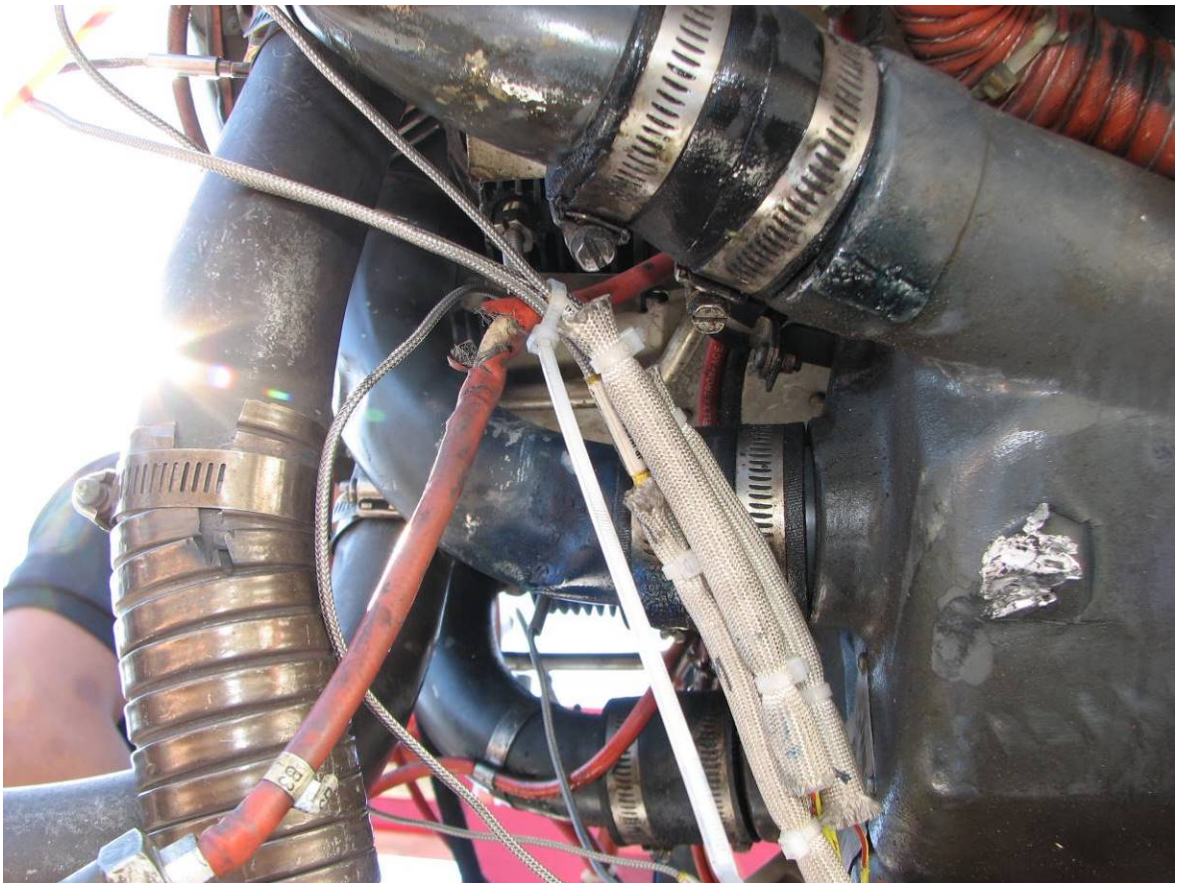
Damaged magneto harness

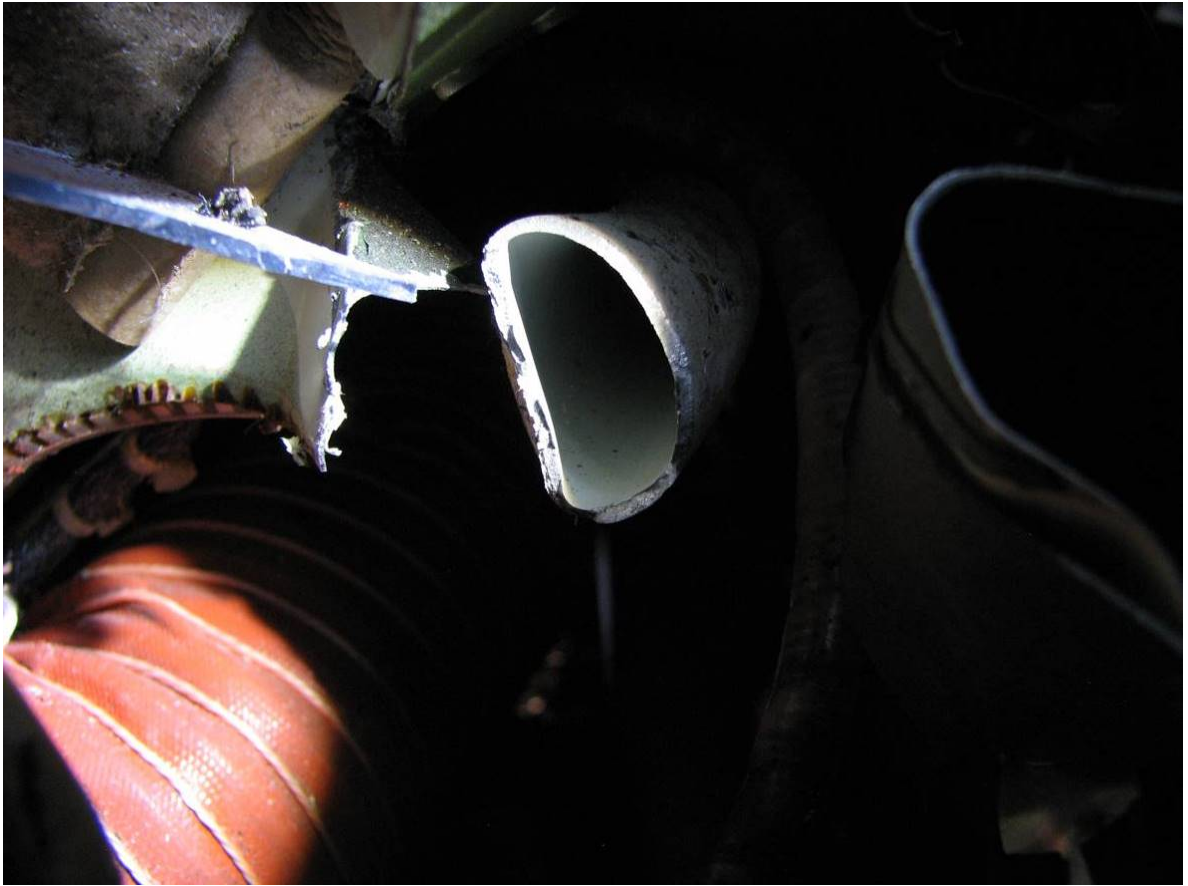
Disconnect TC in the C121-9 push pull tube
